Gulco Marine Maintenance Superfund Site

Wetland Sediment Hot Spot
Remediation Meeting

May 17, 2010

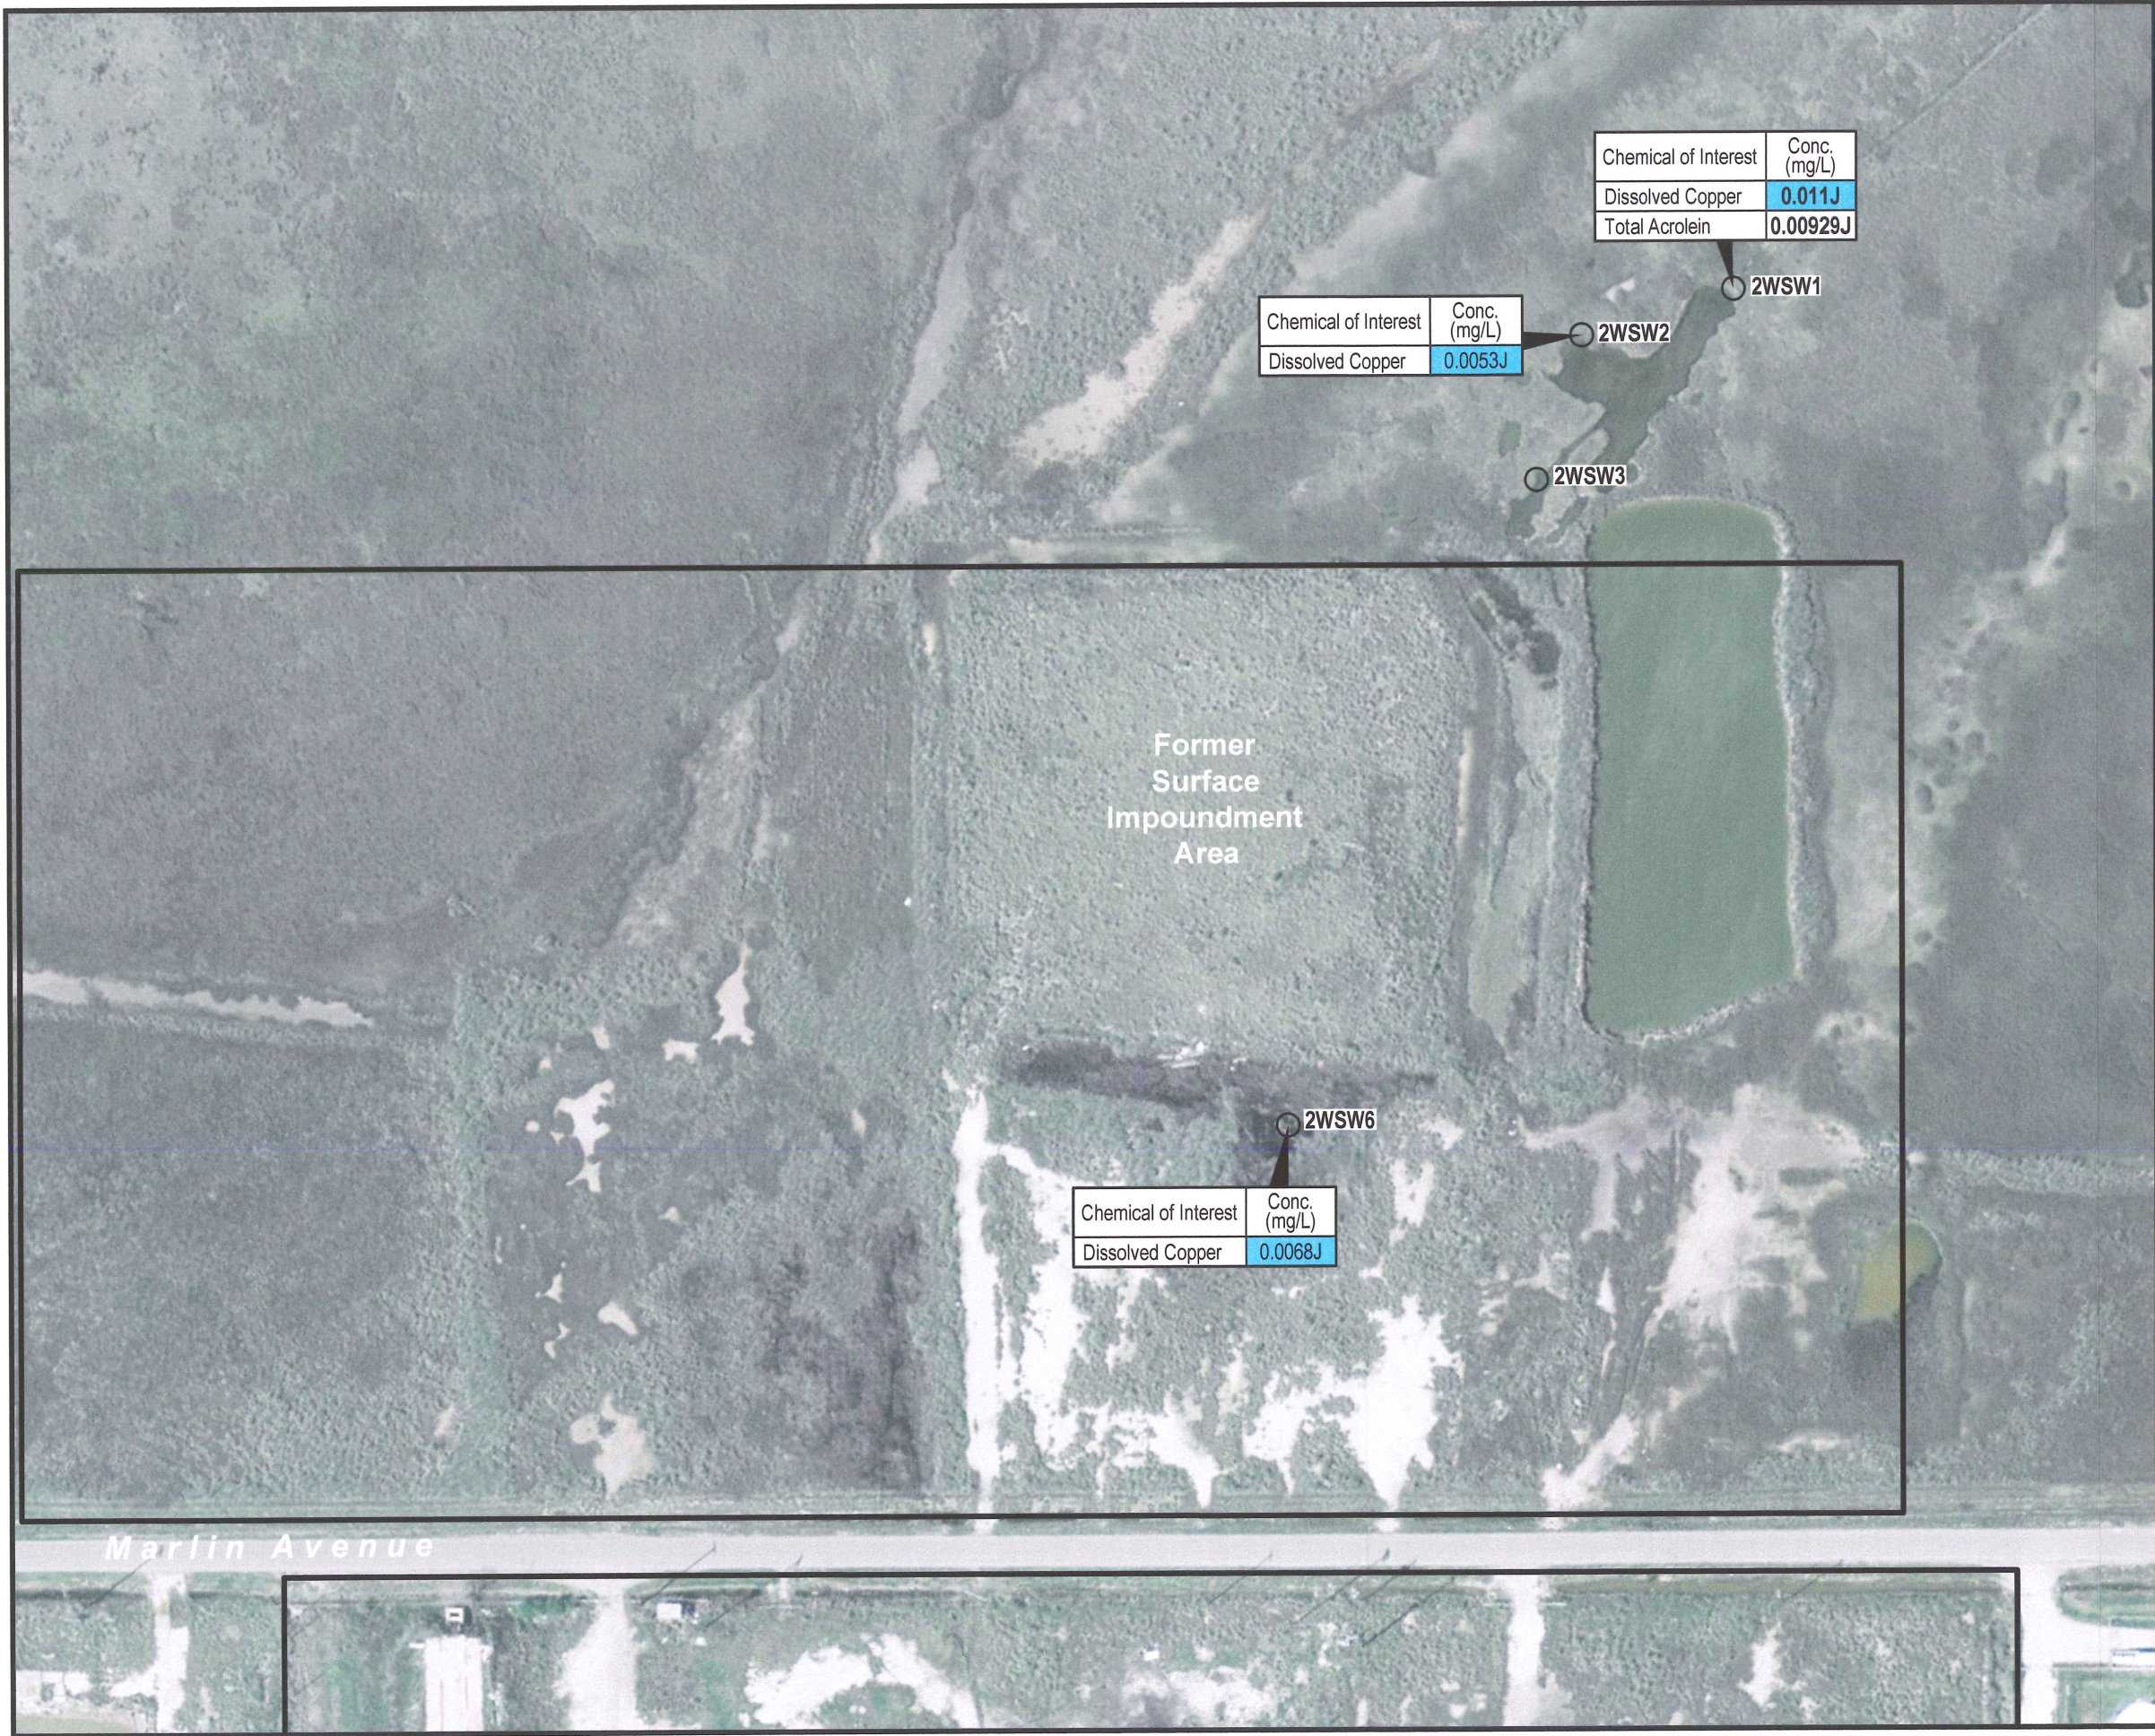
Figure 14
**DETECTED CONCENTRATIONS
EXCEEDING ECOLOGICAL SCREENING
LEVELS FOR AQUATIC RECEPTORS*
- WETLAND SURFACE WATER**

- Notes:**
- 1. Data Qualifier: J = Estimated value.
 - 2. Light blue highlighted values exceed concentrations measured in background surface water (See Figure 13 for background surface water concentrations).
 - 3. Bolded values are the maximum measured concentration for that compound.
 - * Values shown in the figure exceed the TCEQ Ecological Benchmark for Water (See Tables 12 & 16).

- No higher trophic level receptor HQs >1
- Two 2 COPECs exceed surface water quality criteria
 - Copper: 3 exceedences below ICWW background
 - Acrolein: sole detection
- North exceedence areas addressed by wetland hot spot remediation
- South exceedence area will be under repaired cap

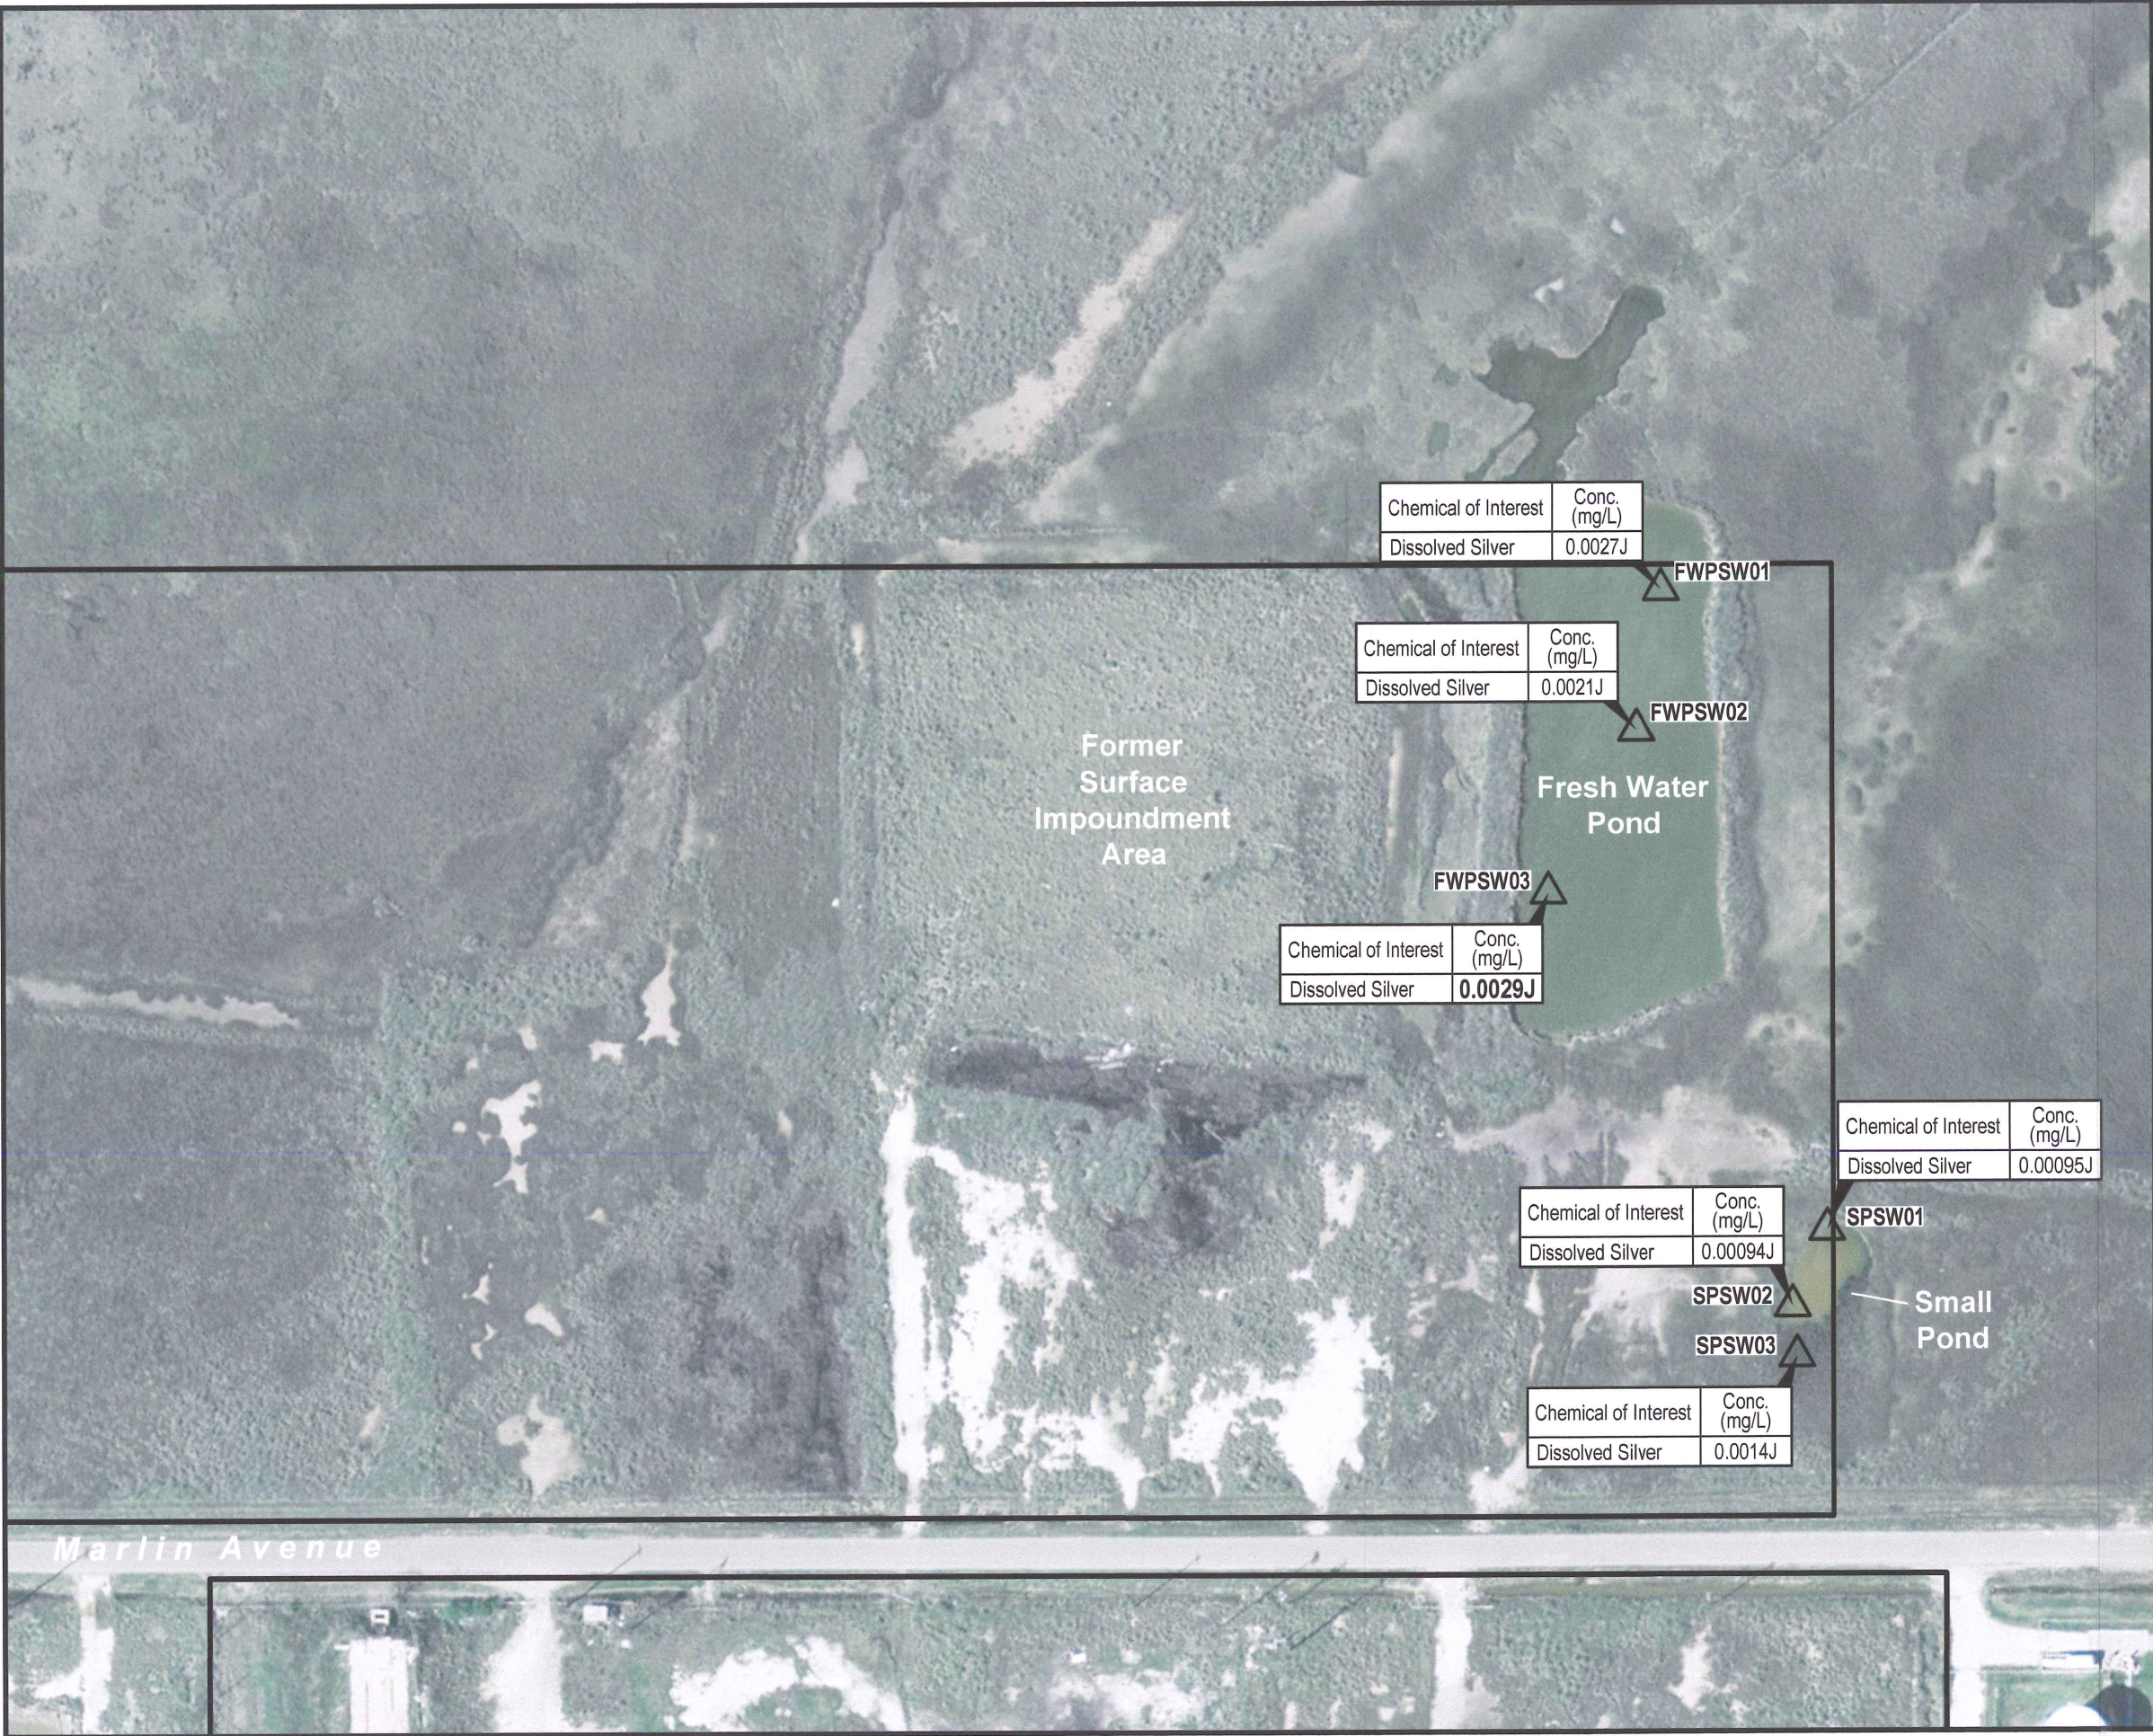
Figure 15

1. Data Qualifier: J = Estimated value.
 2. Bolded values are the maximum measured concentration for that compound.
 3. No compounds were measured above background concentrations (See Figure 13 for background surface water concentrations).
- * Values shown in the figure exceed the TCEQ Ecological Benchmark for Water (See Tables 13 & 17).

**DETECTED CONCENTRATIONS
EXCEEDING ECOLOGICAL SCREENING
LEVELS FOR AQUATIC RECEPTORS*
- PONDS SURFACE WATER**

- No higher trophic level HQs >1
- Silver only COPEC measured above surface water quality criteria
- All silver Pond concentrations below ICWW background silver concentrations
